**AN ASSESSMENT OF
ABANDONED MINES IN
NORTHERN SASKATCHEWAN
(YEAR 3)**

MAY, 2003

**PREPARED FOR:
SASKATCHEWAN ENVIRONMENT**

Prepared by: Clifton Associates Ltd.
on behalf of
P.A.N.S. Joint Venture

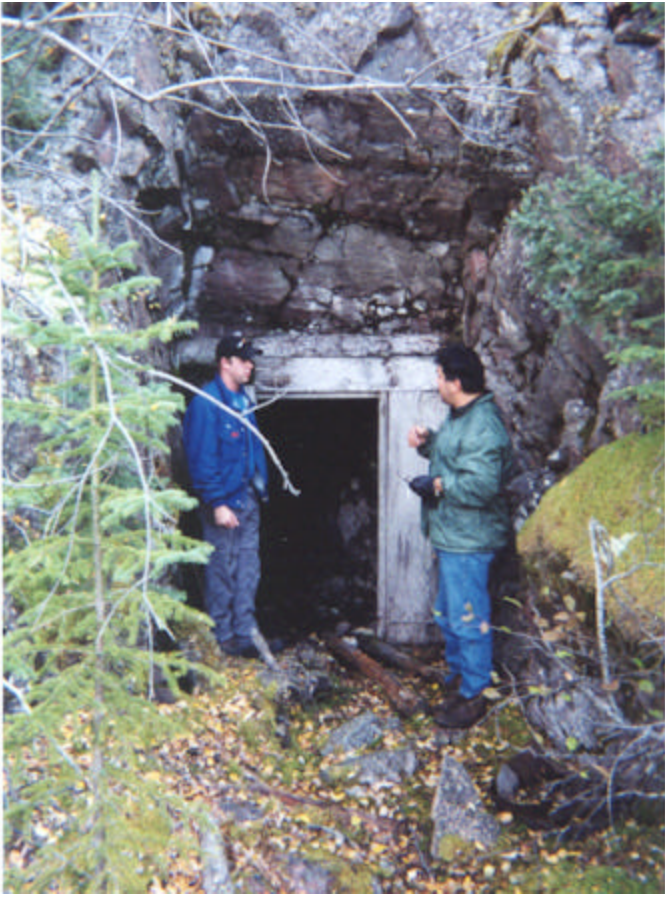
The adit opening is about 2 m wide by 1.5 m high. There is a steep drop from the hillside down to the adit. A small amount of debris is spread about the site.

Photograph 6.2-1. New Mylamaque
Site-Portal-September 30. 2002

Follow-up work should include pushing debris into the adit and blasting it shut or sealing the adit with a secure metal or concrete cover.

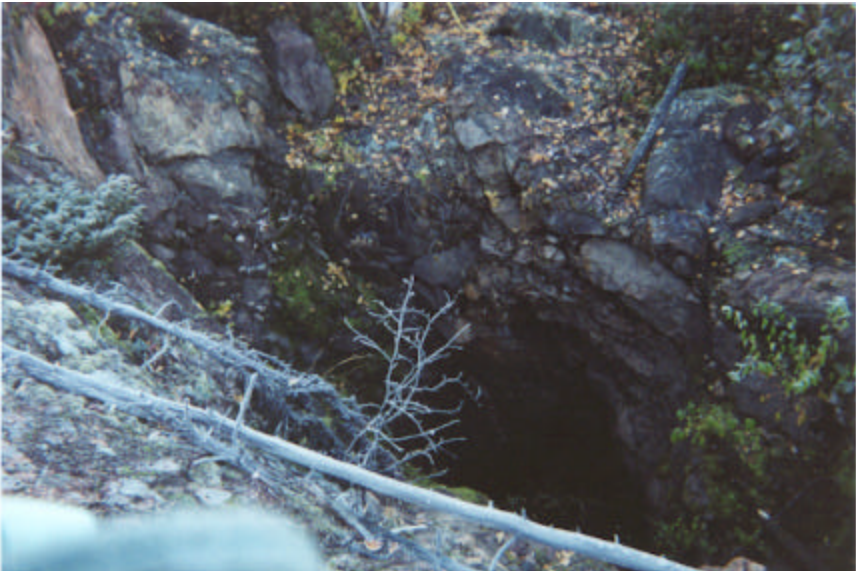
Photograph 6.3-1. Rix Athabasca
Site-Open Trench-October 01, 2002

Follow-up work should focus on pushing waste rock and debris back into the trench to remove the public safety hazard and to reduce the gamma exposure present by the waste rock.

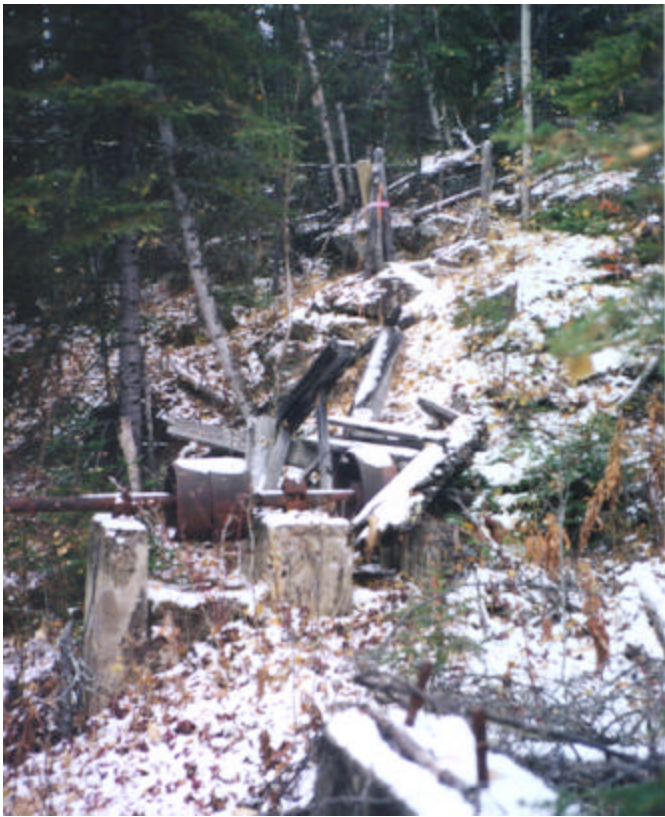
Photograph 6.7-4. Prince Albert Mine-Concrete Footings and Debris-October 18, 2002

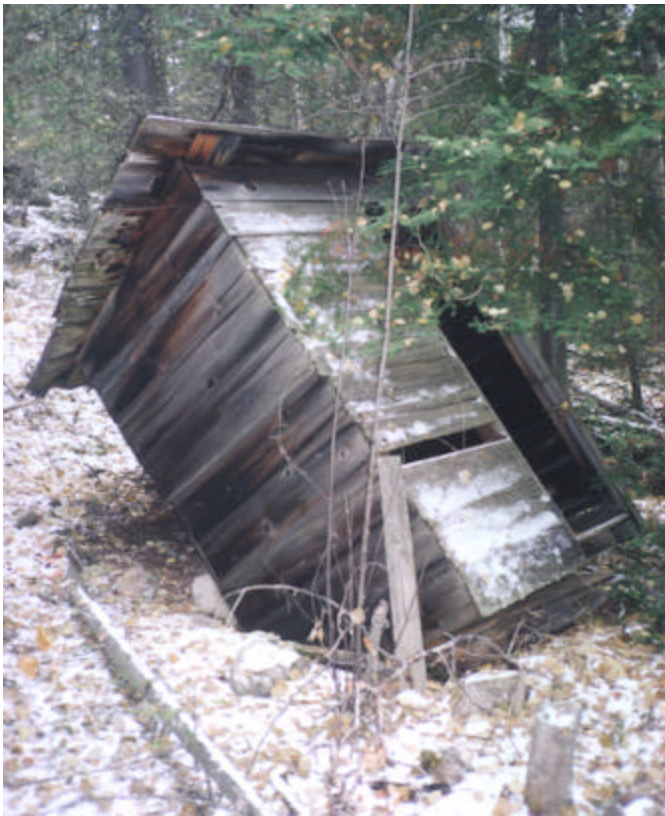
Photograph 6.7-6. Prince Albert Mine-Delapidated Building-October 18, 2002

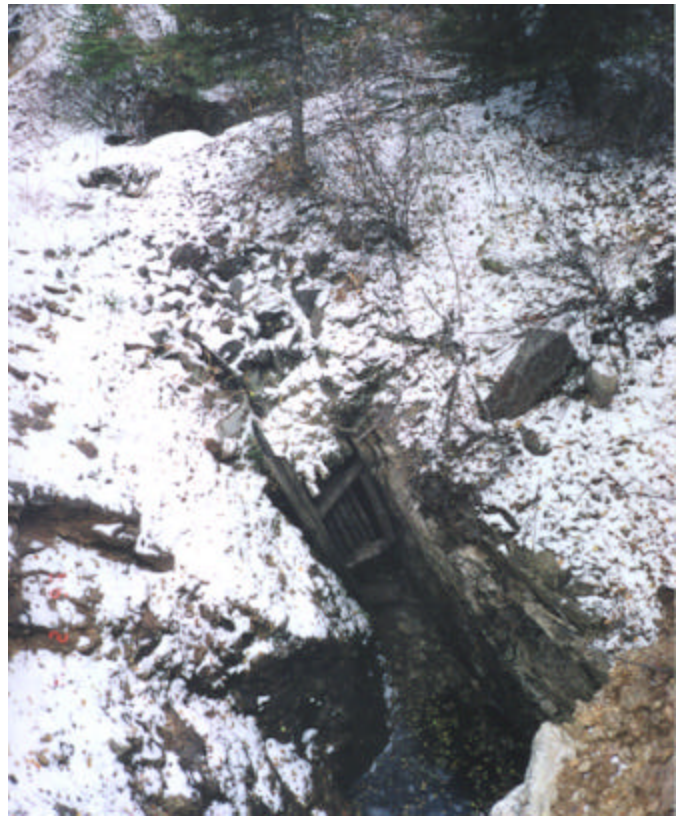
Photograph 6.7-7. Prince Albert Mine-Inclined Shaft and Stone-October 18, 2002

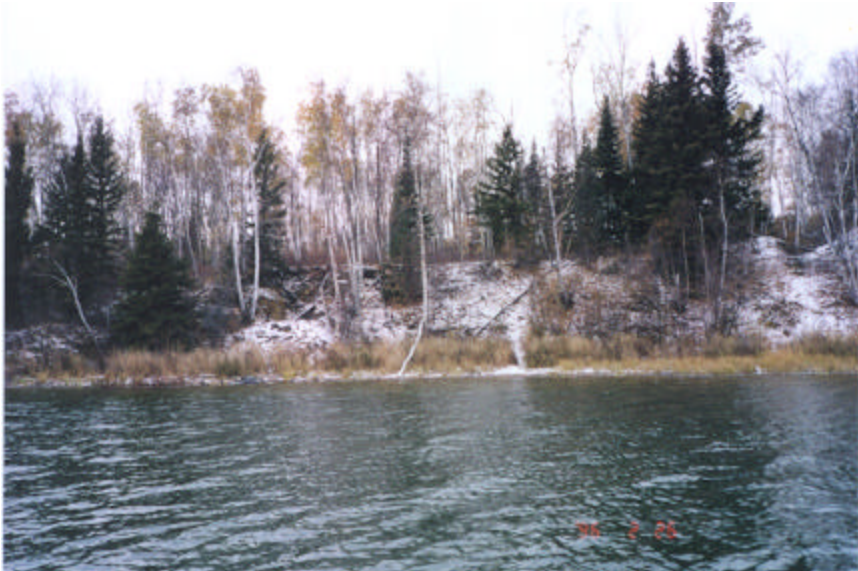
Photograph 6.10-1. Beaver Mine-View
Along Shoreline-October 19, 2002.

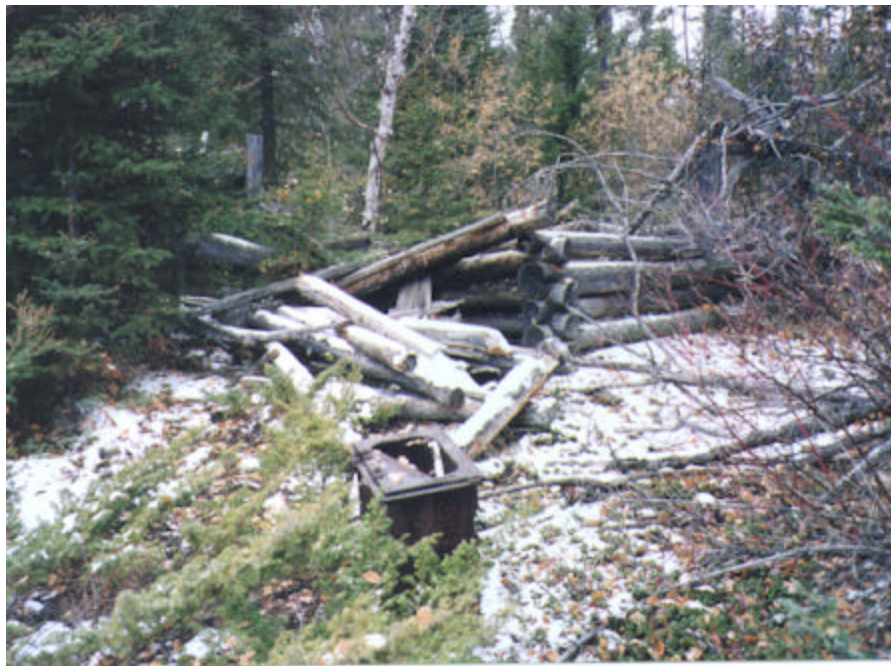
Photograph 6.12-2. Sonora Deposit-Trench 'E'-October 20, 2002.

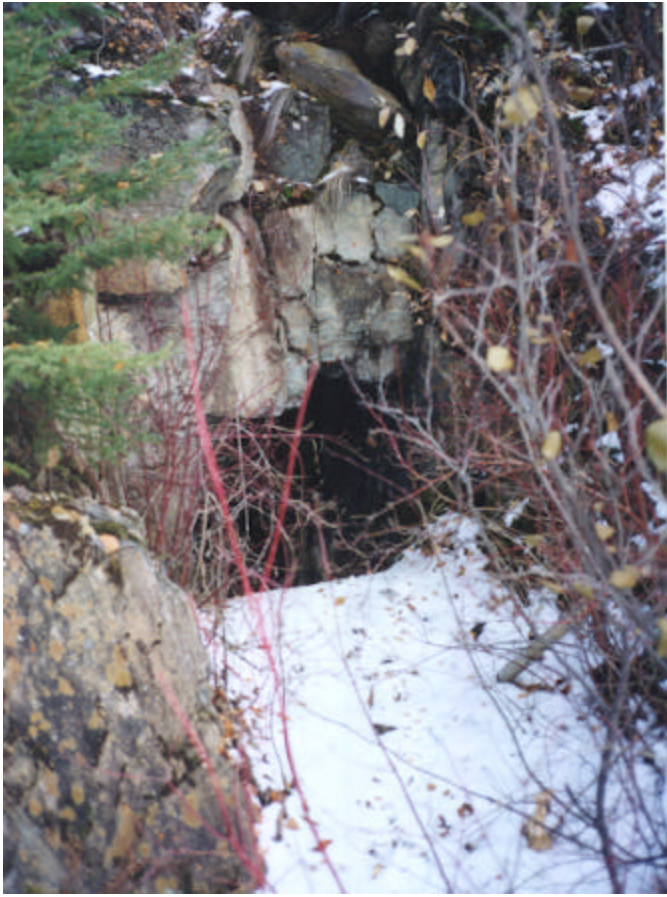
The West Adit occurs on the west side of the ridge, about 6m above the lake shoreline. A rock cut (1.2 m wide and 4m long) into the bedrock, forms the entrance to the adit opening. The adit opening itself is 1.2 m wide and 1.4 m high, slopes slightly downward to the east, and is easily entered. The adit is 30 m long, with the east half flooded with water to a depth of about 0.6 m. The water level in the adit is well above the adjacent lake. No external discharge from the adit was observed. Overall rock stability is good, but loose boulders and soil occur above the opening and fallen rock has accumulated at the adit entrance. Inside the adit, loose rock was visible on the back (ceiling) and has also fallen onto the floor. The West Adit presents a public safety hazard, if entered or approached blindly from the upslope side.

Photograph 6.15-4. Amisk Syndicate Mine-West Adit Portal-October 21, 2002.

Follow-up work is required at the site to seal the openings to the two adits, either by blasting down the entrance way rocks or placement of a concrete seal over the openings. Blasting would also reduce the vertical wall heights, lessening risk of a fall hazard. Hazard warning placards should be posted should reclamation activity be delayed.

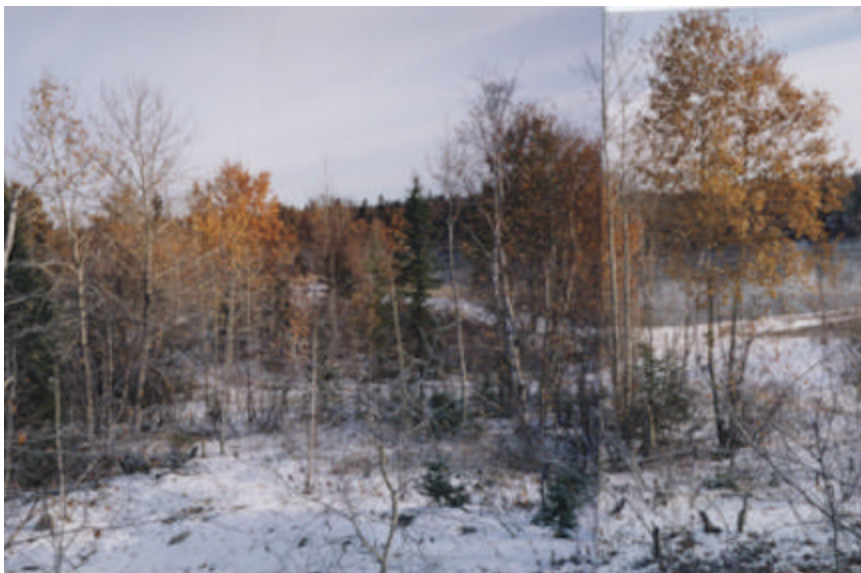
Photograph 6.18-4. Birch Lake Mine-Panoramic View Looking North-October 23, 2002.

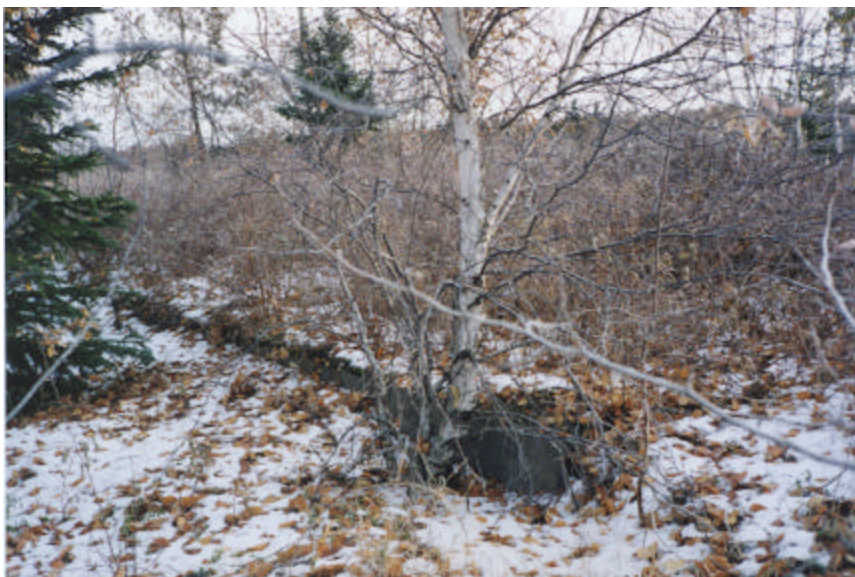
Photograph 6.18-5. Birch Lake Mine-Concrete Slab-October 23, 2002.

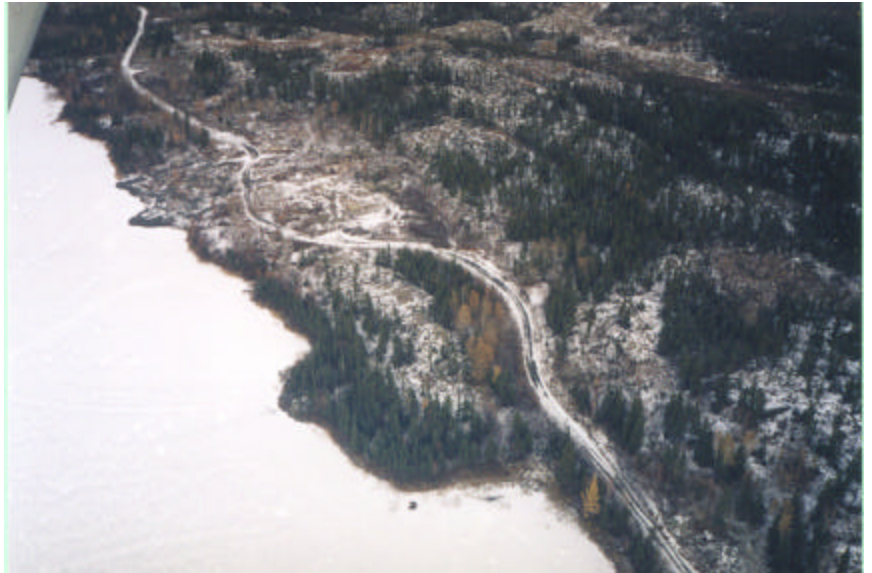
Photograph 6.19-1. Newcor Mine Site
Aerial View-October 23, 2002

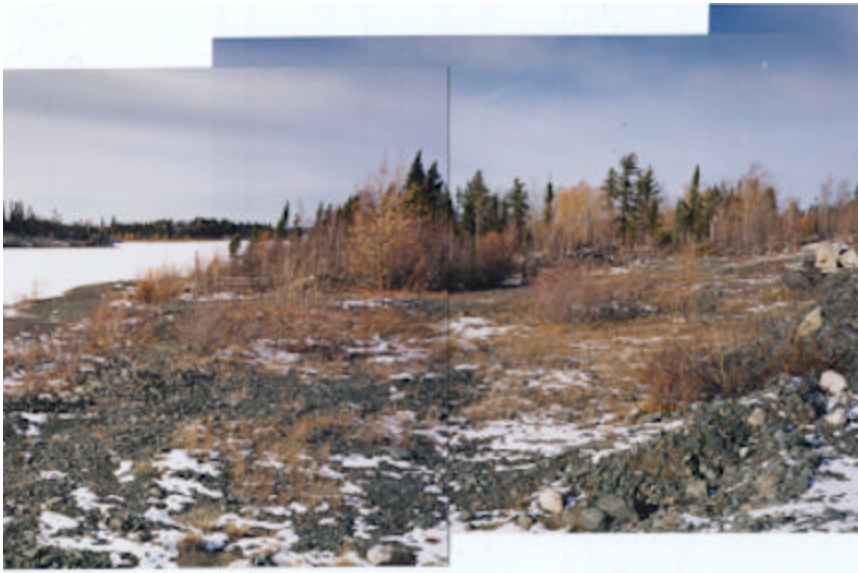
Photograph 6.19-2. Newcor Mine
Site-Panoramic View-October 24, 2002

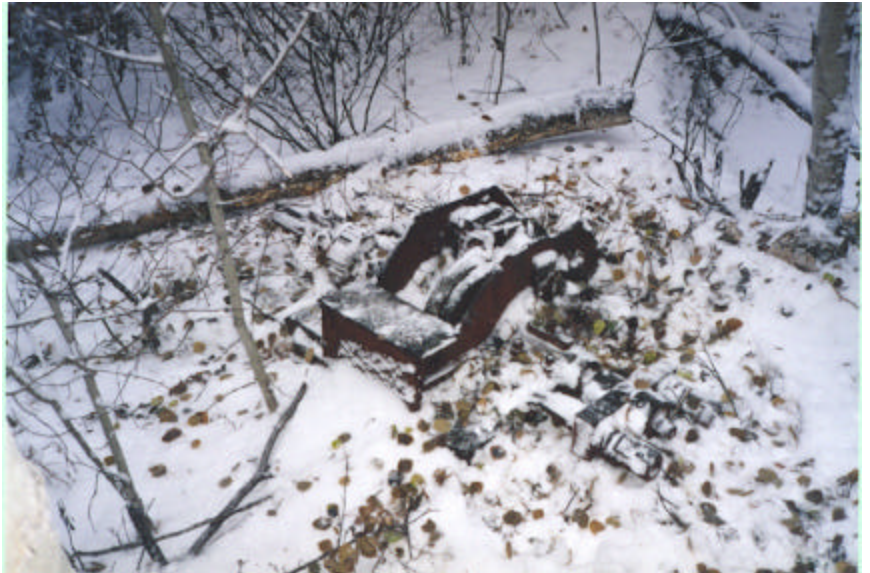
Photograph 6.24-8. Graham Mine-Collapsed Log Cabins-October 25, 2002.

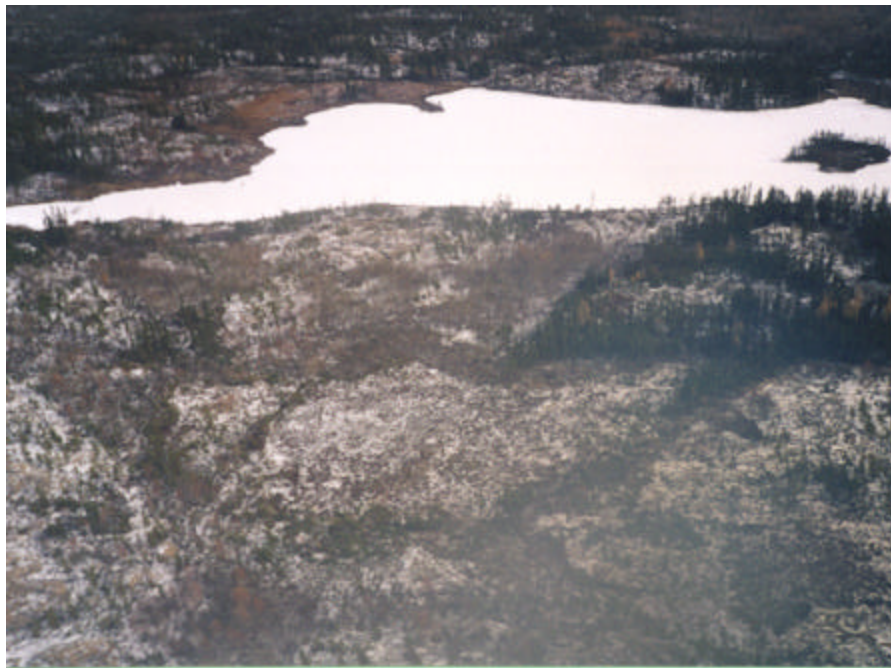
Photograph 6.27-1. Dion Lake Showing and Shaft-Collecting Water Sample at Exploration

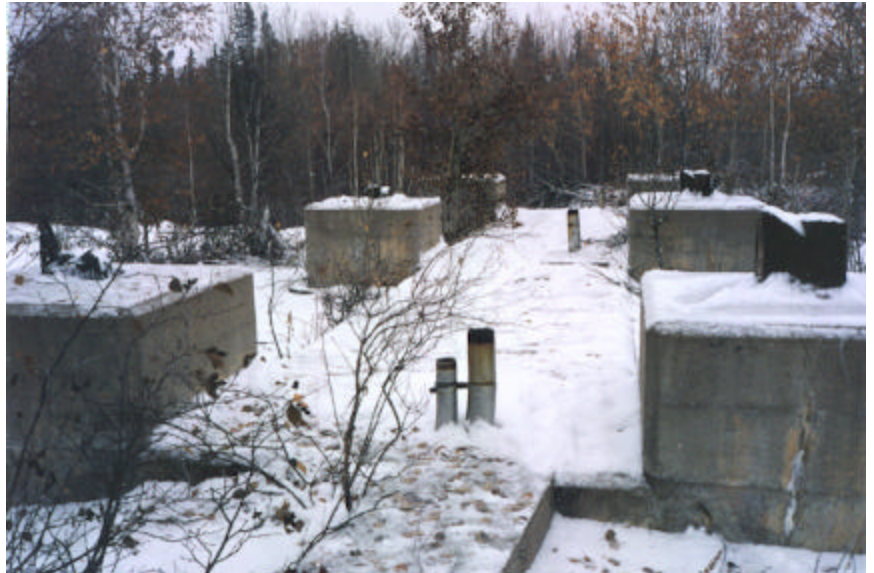
Photograph 6.29-4. Coronation Mine-Concrete Slab and Footings-October 28, 2002.

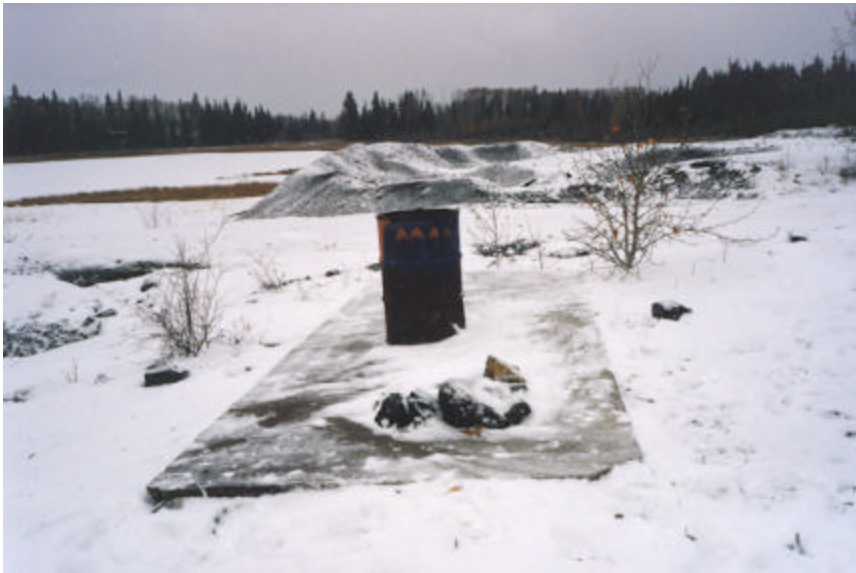
Photograph 6.29-5. Coronation Mine-Concrete Slab 'C'-October 28, 2002.
